# Automatic Visual Inspection System

## - Detection of Insulator's Minute Crack -

### Abstract

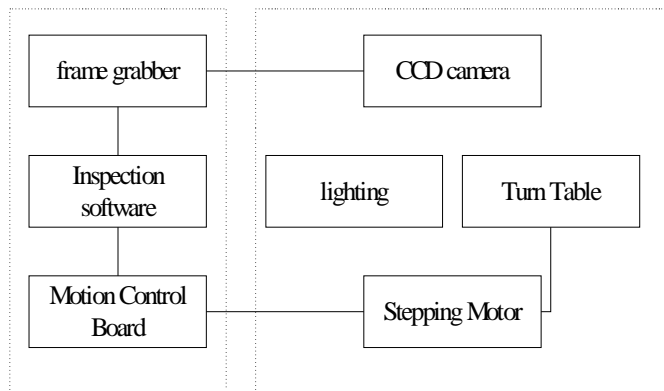
Figure 2. Components of the System

The system we have developed consists as the figure 1. The pulses which the motion control board generates can activate the stepping motor, and the motor rotates a

suspension insulator and then we take images by using CCD cameras and a frame-grabber. After acquiring the images, we pre-process them and try to detect minute cracks. At this time, the role of illumination is very important.
